19 November 2022

MERDON CASTLE, NEAR HURSLEY, HANTS

Observations on the Historic Architecture

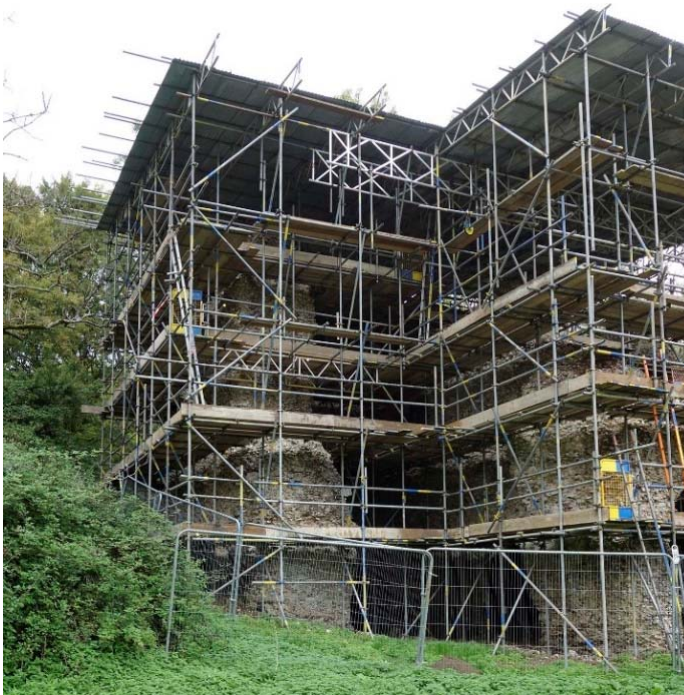
Interpretation of the building is made more challenging because of the major loss of primary surfaces, both external and internal, resulting from deliberate robbing of facing masonry, frost action, and collapse—notably the loss of the south-west corner of the structure. Apart from a few tiny fragments, almost all that survives is corework, for in some areas the upstanding elevations appear to be up to a metre back from the original wall faces. The form and position of features such as vaults, doorways, windows, stairs has to be worked out from fragmentary remains, or from the way the corework has eroded.

Figure 7. Gatehouse from the south-west. The south-west corner of the building appears to have been totally lost.

- 5.4 The reasons for the loss of the south-west corner (weakening because of an internal stair within the side wall, and a possible doorway at ground level) are discussed more fully below. To check the location of the original south-west corner a small trial trench had been excavated by the contractors at the intersection of the extrapolated line of the west and south walls (Figure 8).
- 5.5 This revealed what might be flint corework, but it also included what looks like a fragment of brick, which would be inconsistent with twelfth-century work. The excavation needs to be enlarged, and to penetrate the flintwork to check the mortar type.

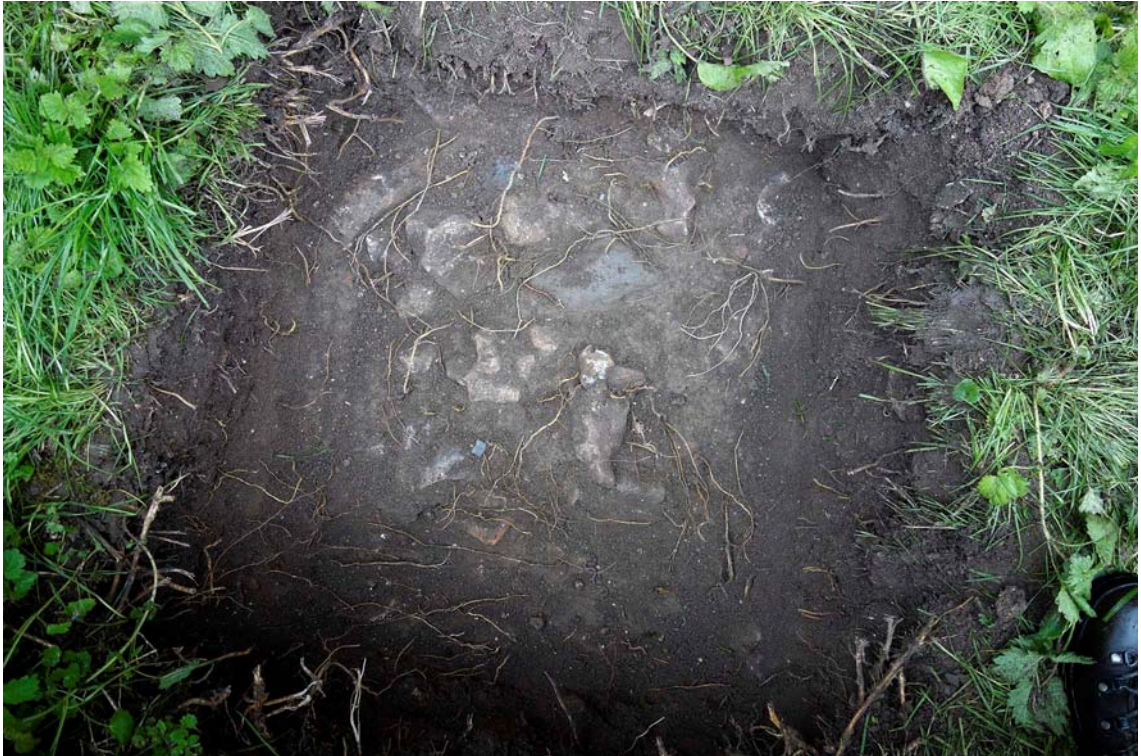
Figure 8. Excavated possible flint corework at extrapolated SW corner of the building.

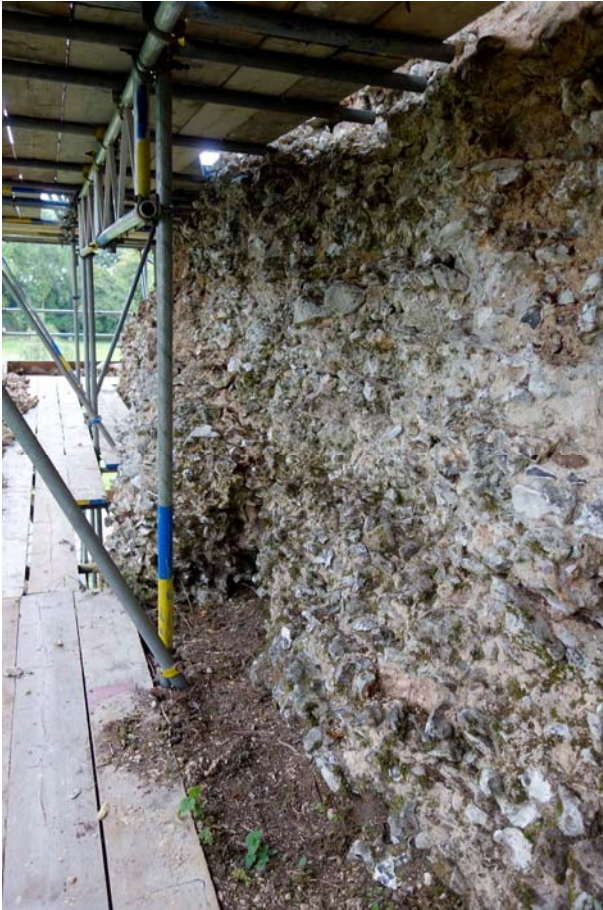
Figure 9. East face of gatehouse, oblique view south, showing possible springing of curtain wall (behind scaffolding standard).

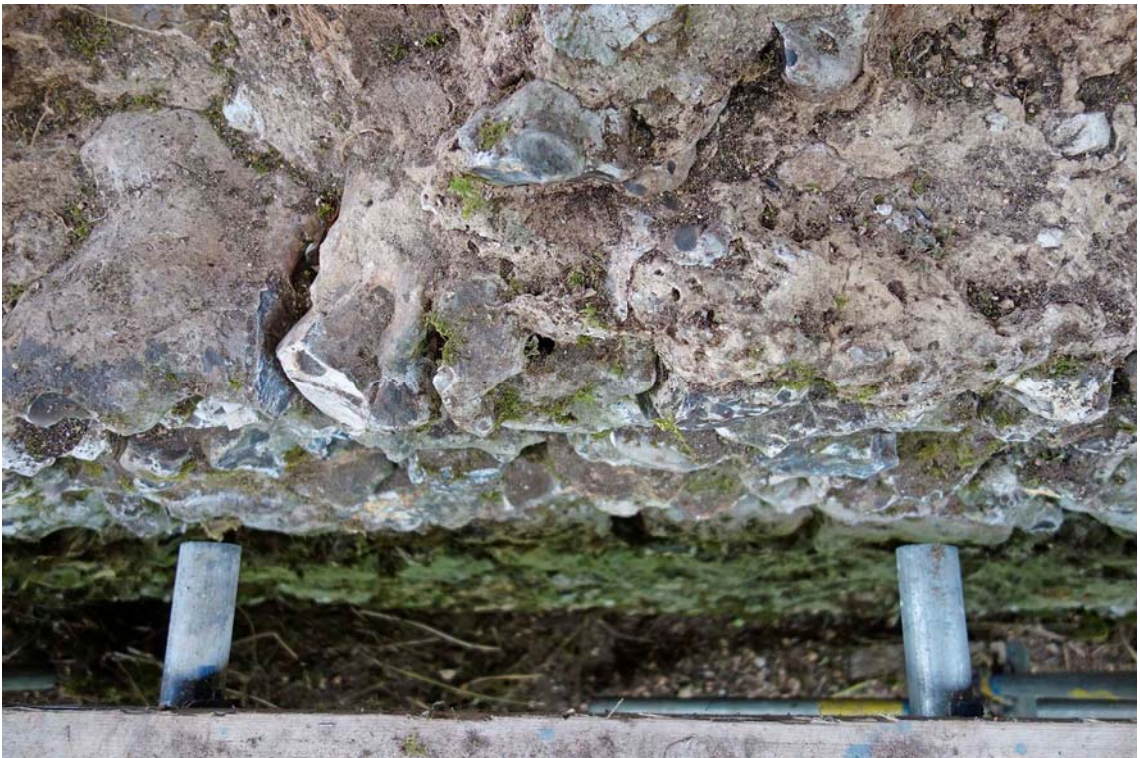
Figure 10. Possible original external wall face: the lowest 4m of north external wall, towards the NE corner of the gatehouse. Above this level (top half of photo) the facing has slumped away.

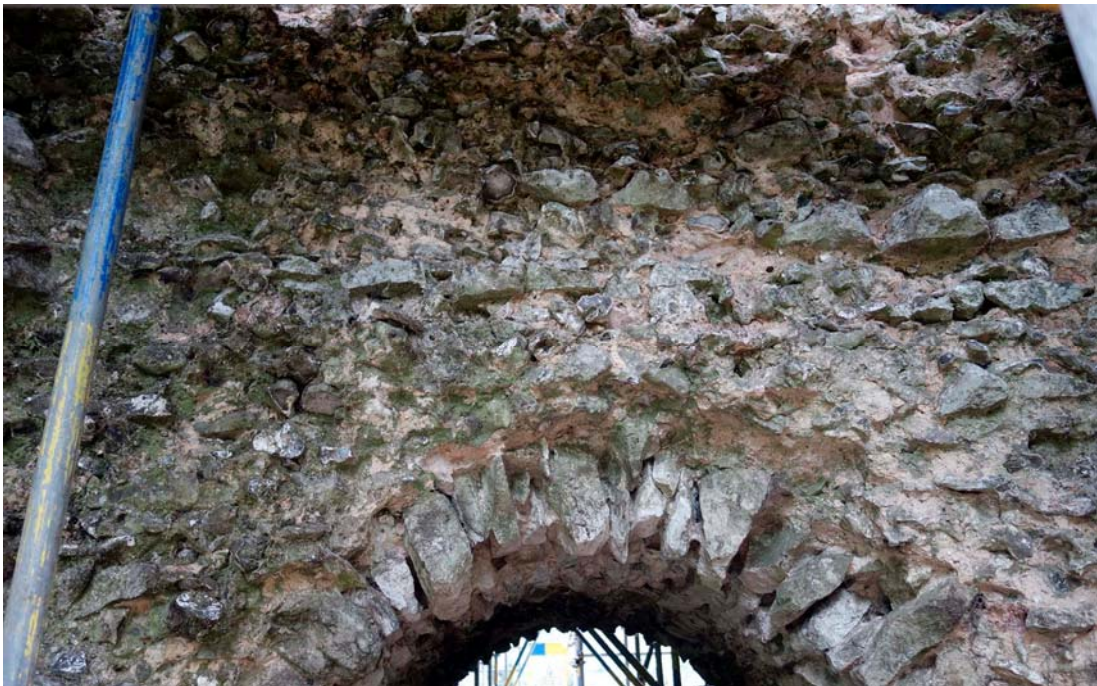
Figure 11. Masonry above north end of entrance passage.

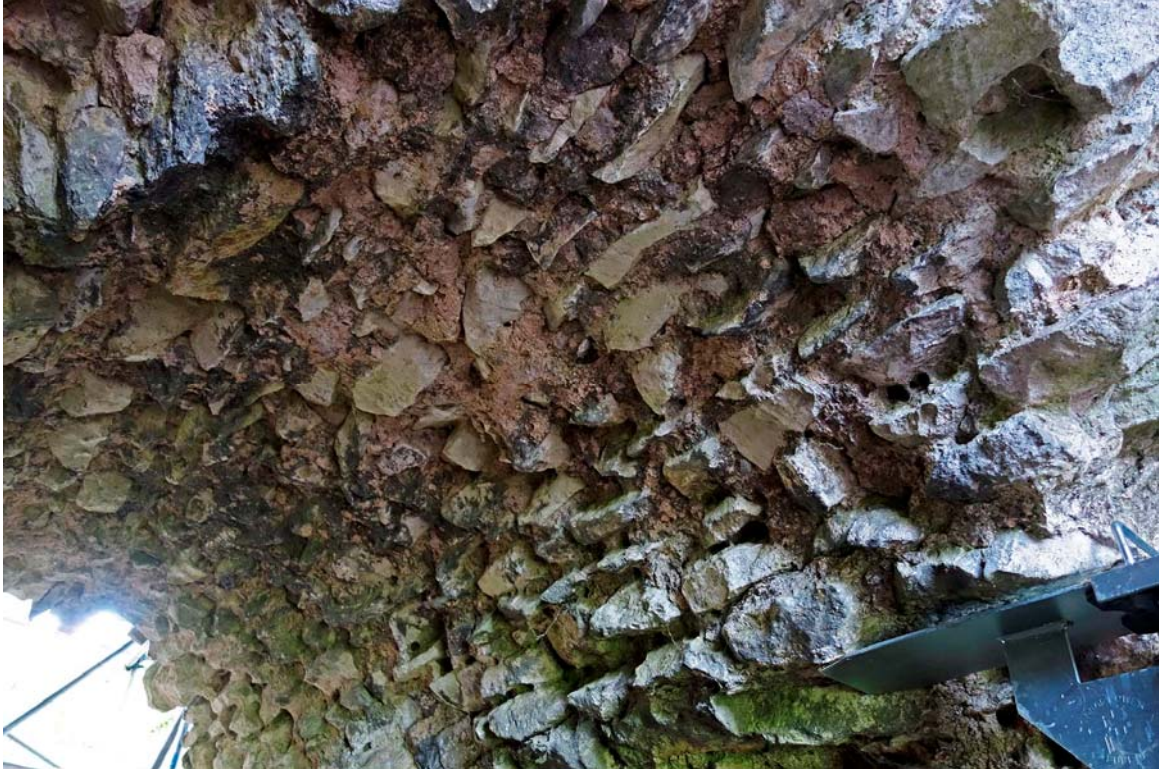
Within the north end of the passage, the soffit of the entrance arch through the thickness of the outer wall comprises thin voussoirs set in pink mortar (Figure 14).

Given the obvious loss of the masonry of the entrance doorway, there can be little doubt that the arch itself was also faced in ashlar, which has been totally robbed. To suggest that the visible corework was simply rendered is untenable. The question might be totally resolved by a small excavation within the passage, to determine the original side wall lines.

Figure 14. Soffit of entrance arch, looking north-east.

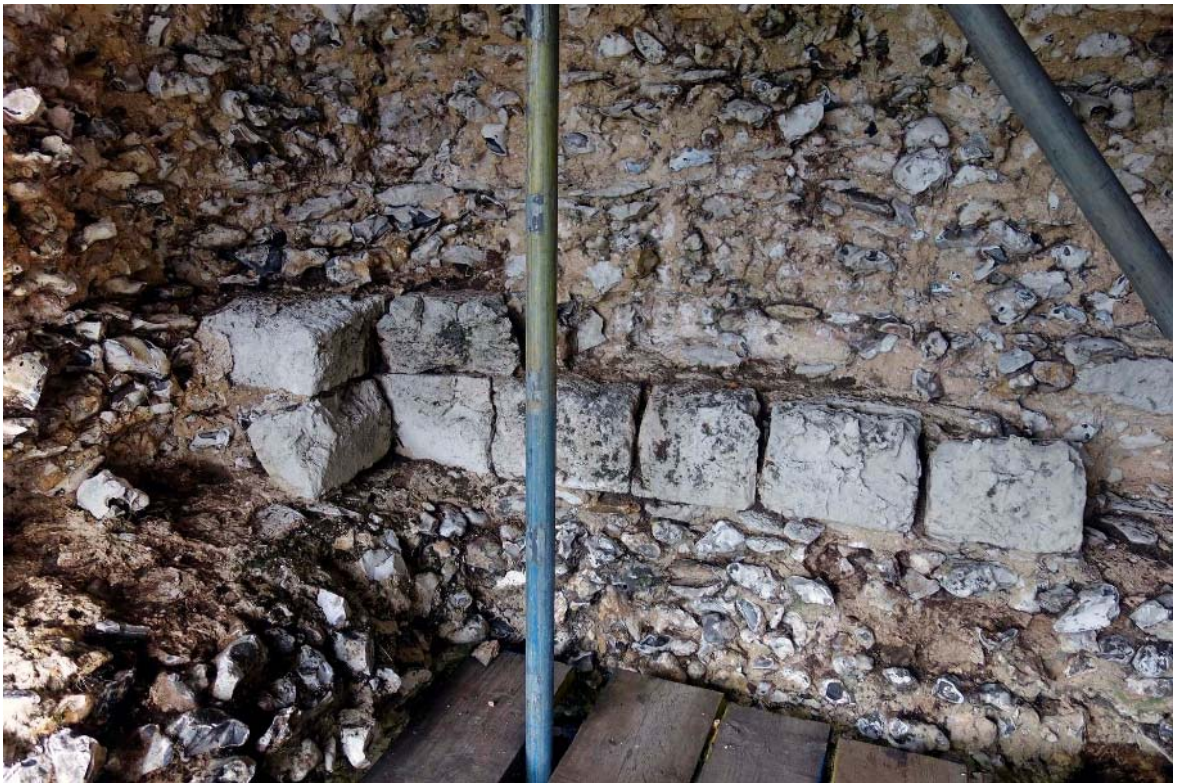
- 8.9 The vault over the gate passage has vanished leaving no evidence, as previously noted, but its approximate level is indicated by a double line of pale limestone (? chalk clunch) blocks on the inner (south) face of the north wall of the gatehouse. Similar features occur elsewhere in the gatehouse, as we shall see; they are not wedge-shaped, and they are set more or less flat. I interpret them as remains of the floor treatment *above* the actual vaults. They cannot reflect the vault itself, as they are flat, not in the form of an arch; assuming the passage was barrel-vaulted, it would have ended in a tympanum above the entrance doorway, but the loss of facing masonry means that none of that has survived.

- 8.10 The survival of these blocks results from the construction sequence. The vault would have been turned as the side walls arose; the blocks comprising the floor were then laid, and when the facing masonry above floor level was laid the edges of the floor were trapped beneath the masonry skin, being revealed when the facing was stripped away. It is just possible that the two blocks comprising a second course in the corner were part of the inner facing masonry.

Figure 17. Row of chalk blocks on inner face of north wall of gatehouse, above the entrance doorway, here identified as deriving from the first floor over the gate passage.

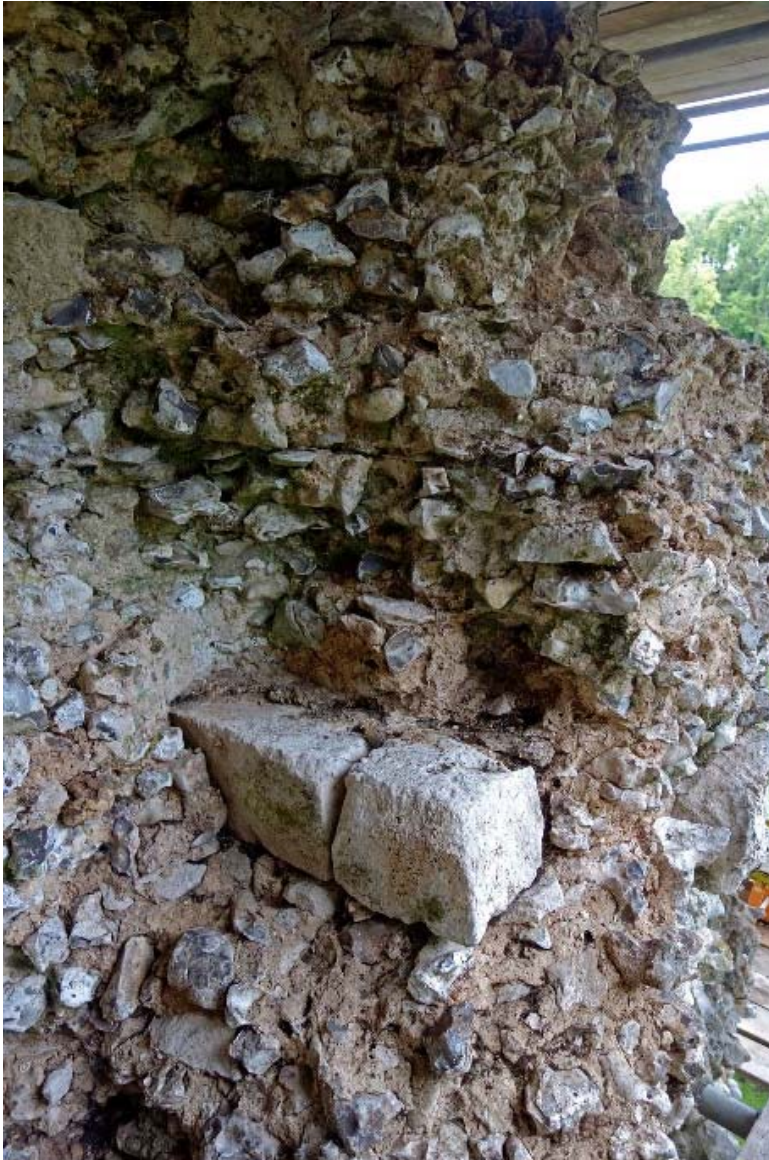
- 8.11 At what by estimation is the same level, embedded within the west face of the spine wall at its south end, i.e. at its former junction with the south wall of the gatehouse, are two further blocks which, it is argued, also derived from the stone floor above the vaulted gate passage (Figure 18).

Figure 18. Looking SE at south end of spine wall, at former return of south wall of the gatehouse.

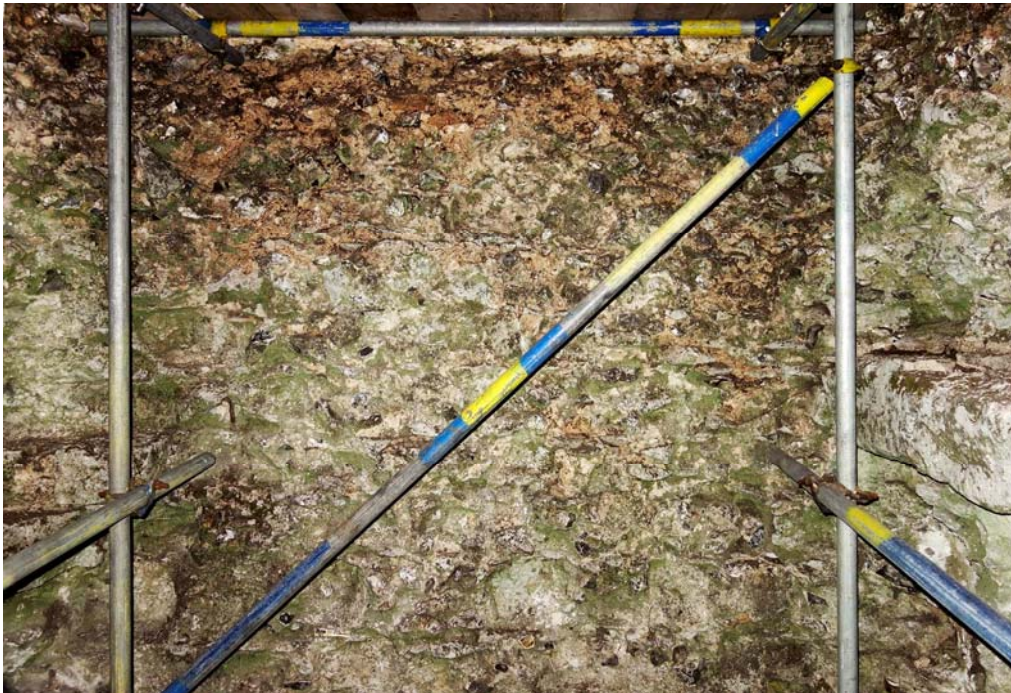
Figure 19. North internal wall face of eastern half of gatehouse at ground level showing banding of corework.

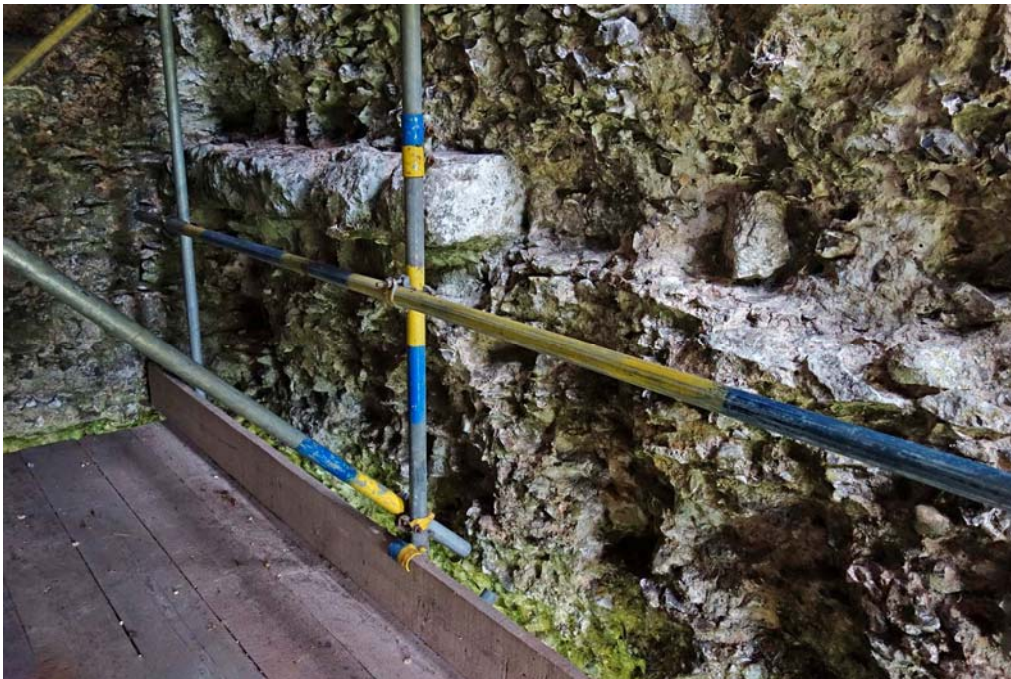
The loss of the facing masonry both on the end and side walls means that most evidence for the vault of the eastern ground-floor room has been lost. That the room was vaulted is however shown by the survival of a few blocks of masonry in the east wall, near the north-east corner (Figure 19, right, Figure 20).

Figure 20. Blocks on inner face of east wall of gatehouse, identified as remains of the floor of the first-floor room.

- 9.5 Below this line of stones (again, probably chalk) the way the corework arches forward result from the vault that undoubtedly underlay the first floor (Figure 20). The vault was probably a plain tunnel (barrel) vault, though the periodic projection of the corework might possibly hint at transverse ribs.
- 9.6 In the south-west corner of the same room (the first-floor room in the eastern half of the gatehouse) another isolated block possibly relates to the same floor level (Figure 21). Initially this was taken to be a surviving element of facing masonry, but that is inconsistent with the corework on the same plane below it, given the good evidence that the gatehouse was faced internally throughout. Any doubt on this point would best be resolved by a levels survey.

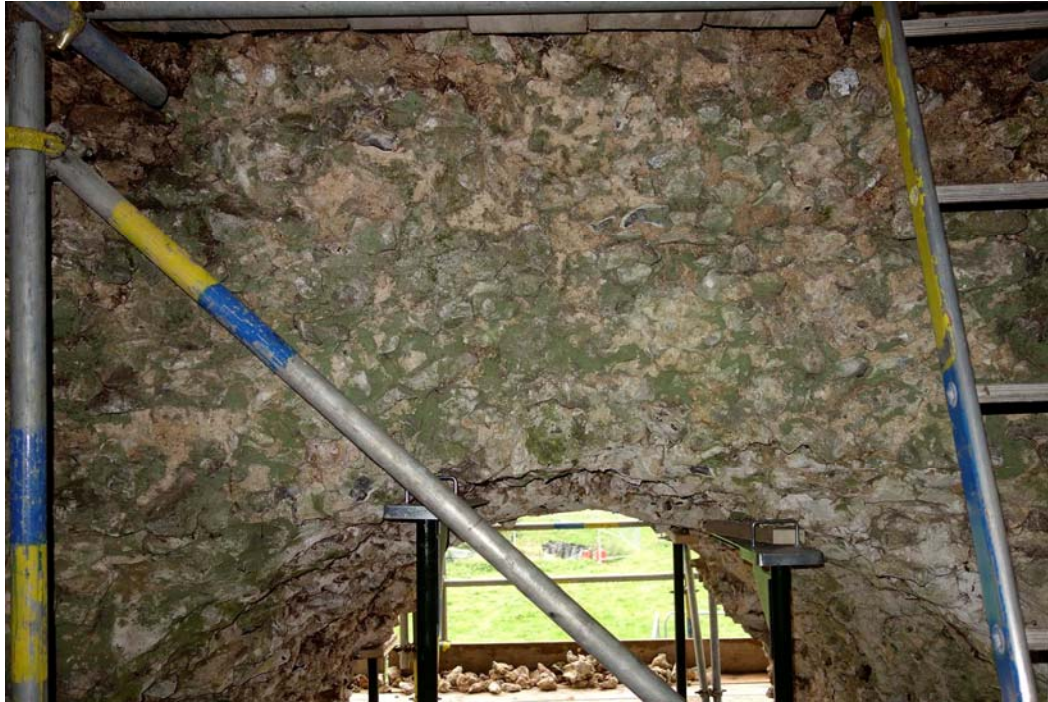
The south wall of the east half of the gatehouse is reasonably intact (Figure 23), but again consists only of corework, all facing masonry of the wall, and the ashlar of the central doorway having been completely lost.

Figure 24. Inner face of south wall of eastern half of the gatehouse.

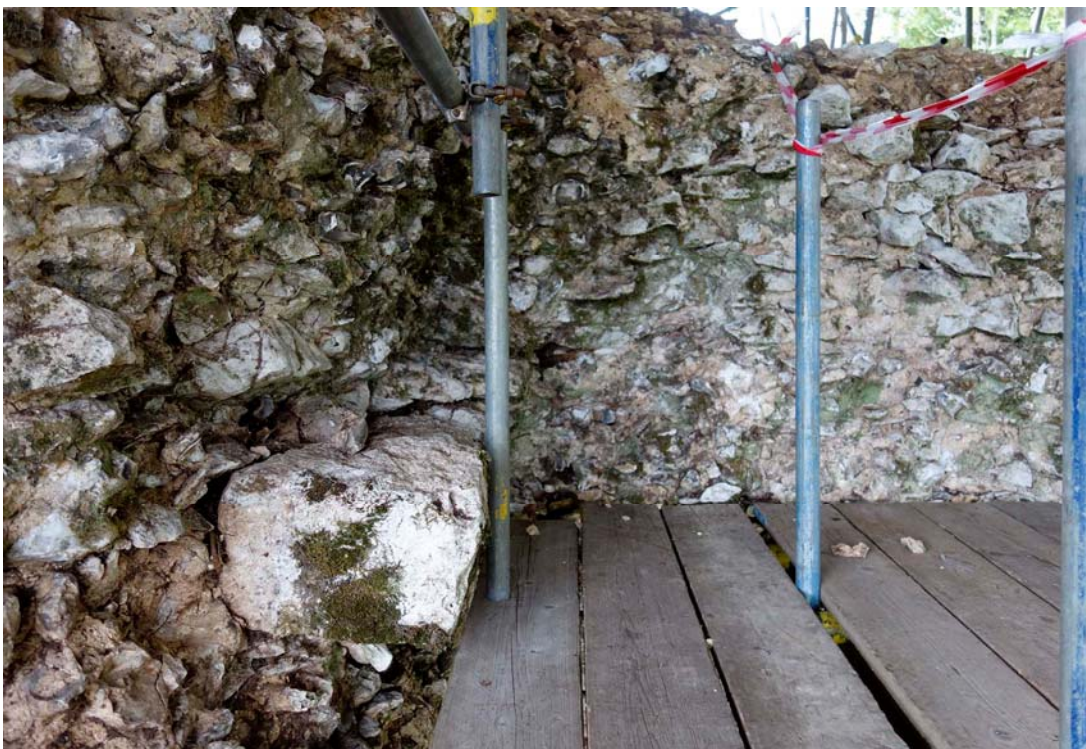
The first-floor rooms appear also to have been vaulted, with a stone floor to the second-floor rooms above. Thus, high in the north-west internal corner are blocks set in the corework similar to those observed at lower level which I interpreted as remains of the first floor (Figure 27). As with the latter floor, the supporting vault has vanished, leaving only the floor blocks trapped within the corework.

Figure 27. View north at level of second floor room over the gate passage, showing chalk blocks embedded in the corework of the inner face of the west wall.

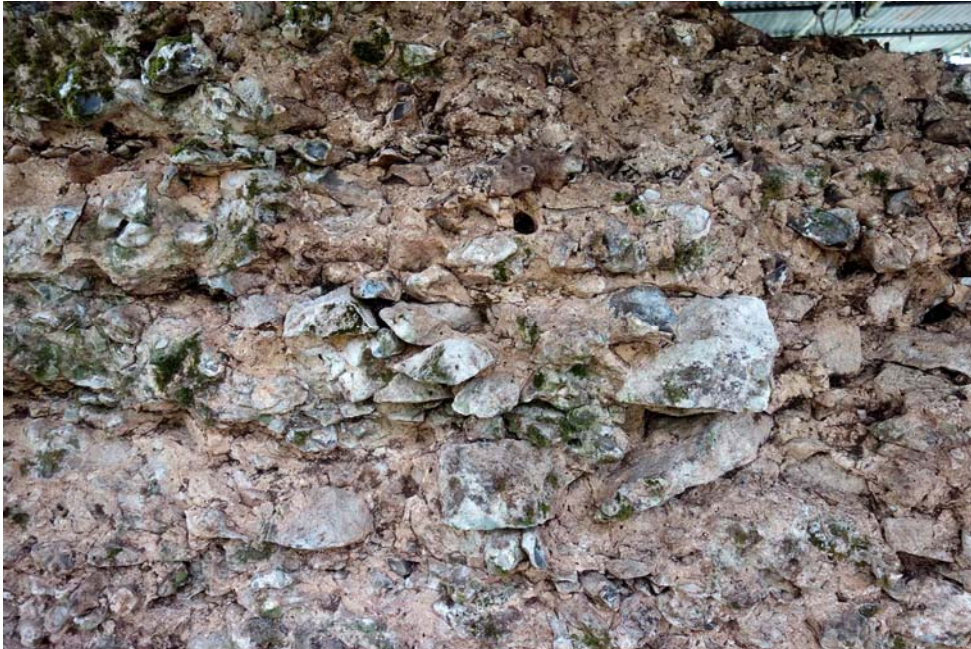
- 10.3 The banded effect in the corework, reflecting the courses of the vanished facing masonry (see para. 9.3, above) was also observed on the inner (south) face of the north wall of the east half of the gatehouse at first-floor level, confirming that the rooms were ashlar faced. It is reasonable to suppose that this also applied to the first and second-floor rooms over the gate passage—in other words, that the building was ashlar faced throughout.

Figure 28. North wall of eastern first floor chamber. Banding of corework.

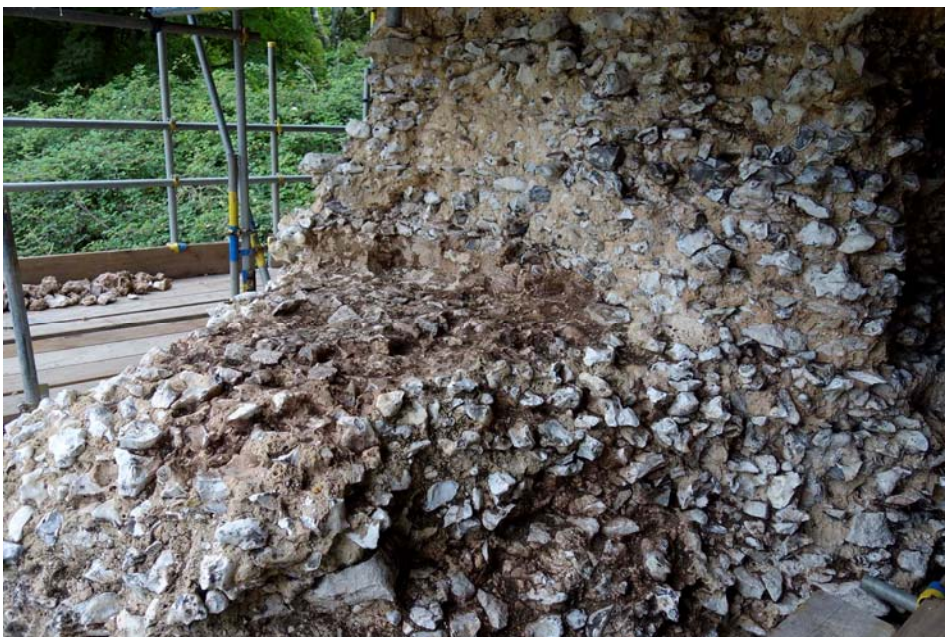
- 11.1 The south end of the west wall of the gatehouse appears to have been lost, as noted above. This may partly have been caused by the weakening of the wall which contained a feature that the Project Surveyor, Simon Goddard, plausibly identified as a stair vice, leading up from first to second floor level.
- 11.2 The surviving remains (Figure 31) consist of a flat platform at the same level as the first floor (as defined by the embedded chalk blocks in the side walls discussed above) and the concave ghost of the north side of the vice, stripped of its ashlar.

Figure 31. Remains of stair vice in the west wall of the gatehouse, leading from first to second floor level. The flat area (centre of photo) stained by earth is identified as the bottom of the vice.

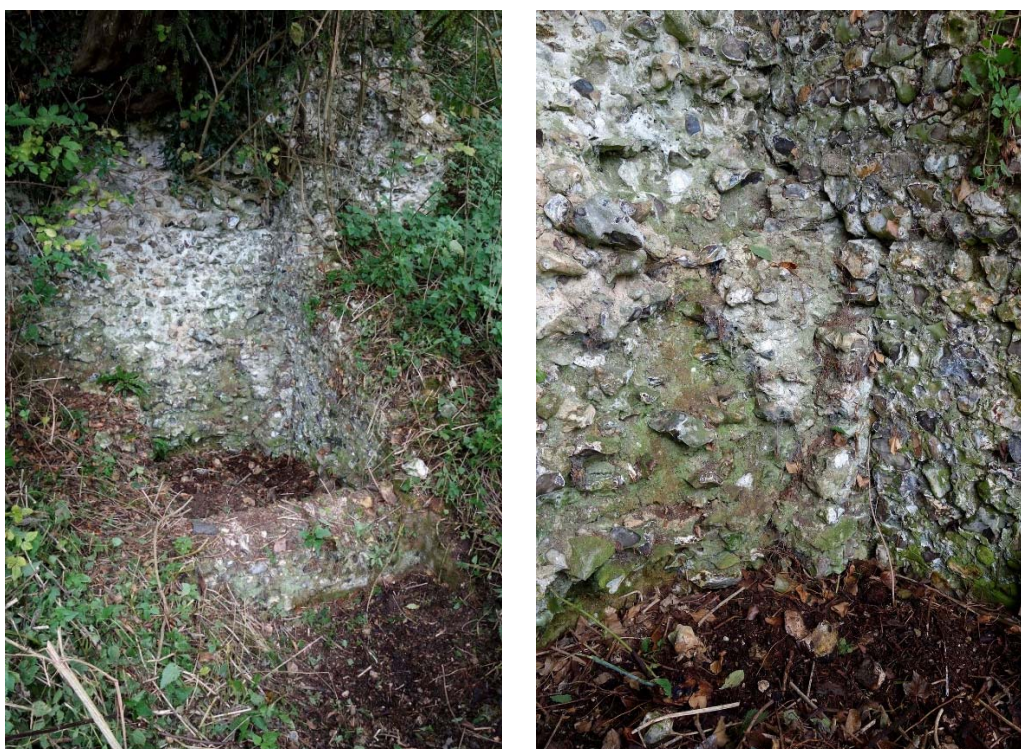
- 14.1 A length of what appears to be the curtain wall survives on the west side of the motte. The area is below trees and the wall surface is mostly concealed by vegetation, but the contractors cleared a small area where a building that was thought to be a possible garderobe had been identified (Figure 36).
- 14.2 The feature consisted of a wall projecting east from the face of the curtain wall, part enclosing a rectangular stone-lined pit. It appeared to be the remains of a square building constructed against curtain wall.

Figure 36. Small building constructed against inner face of curtain wall.

- 14.3 It was apparent that there were two phases of building. In fact, the surviving north side of the building had been constructed against the curtain wall after a considerable amount of the latter wall had been lost to erosion or deliberate robbing, possibly of stone facing (Figure 36, right).
- 14.4 A post-medieval date for this secondary feature was suggested by the survival of a brick fragment in the abutting wall, just above ground level (Figure 37).

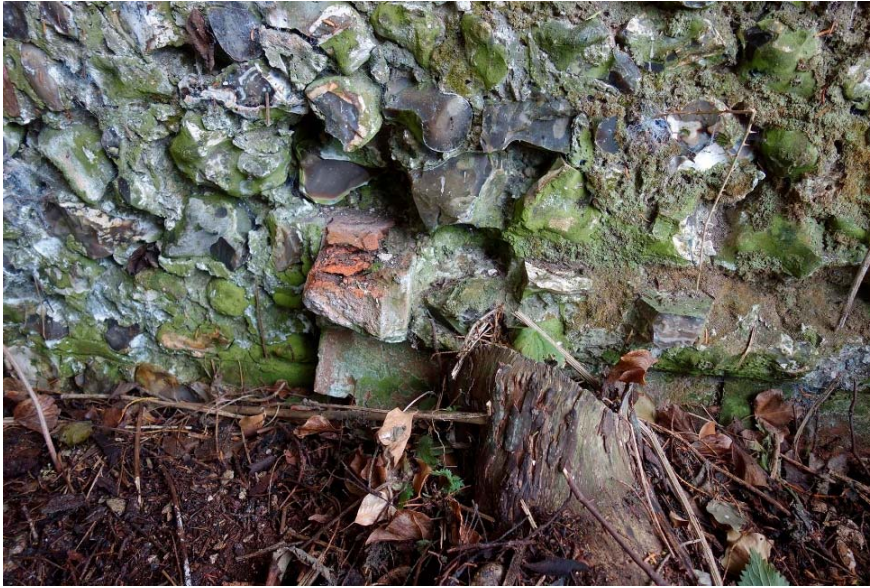
Figure 37. Brick embedded in flintwork of abutting north wall of the square additional building.

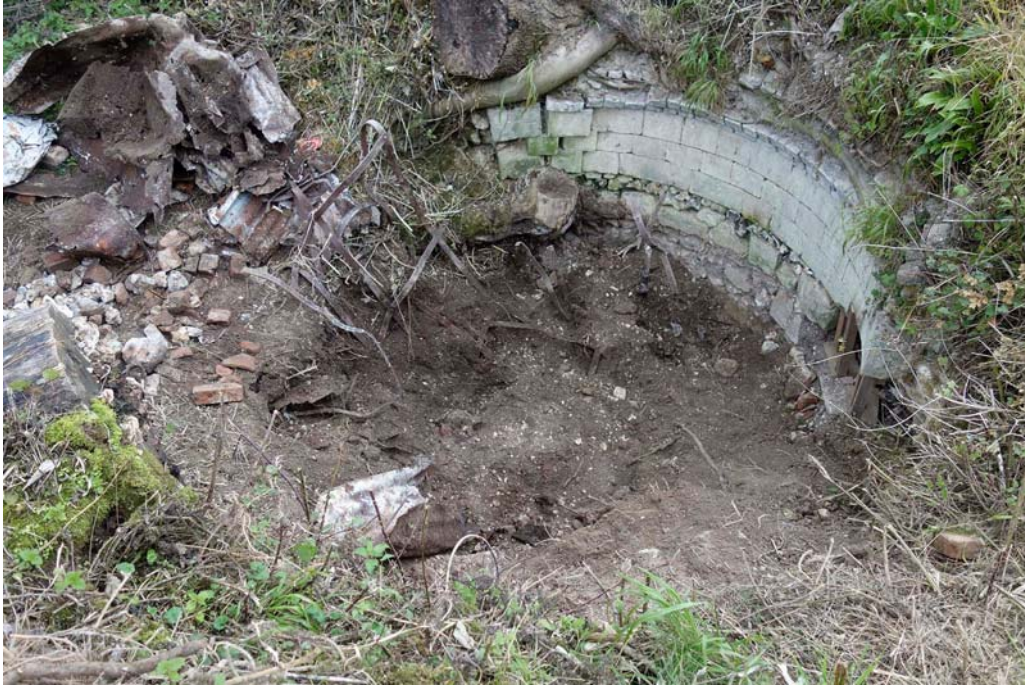
- 15.3 The well itself appeared to be completely blocked, but probing has ascertained that a temporary blocking of recycled iron strapwork had been crudely inserted.
- 15.4 The well had been investigated in the nineteenth century, though the bottom was not reached; and I understand that since my visit the shaft is now accessible.

Figure 39. Looking down into well from SSE.

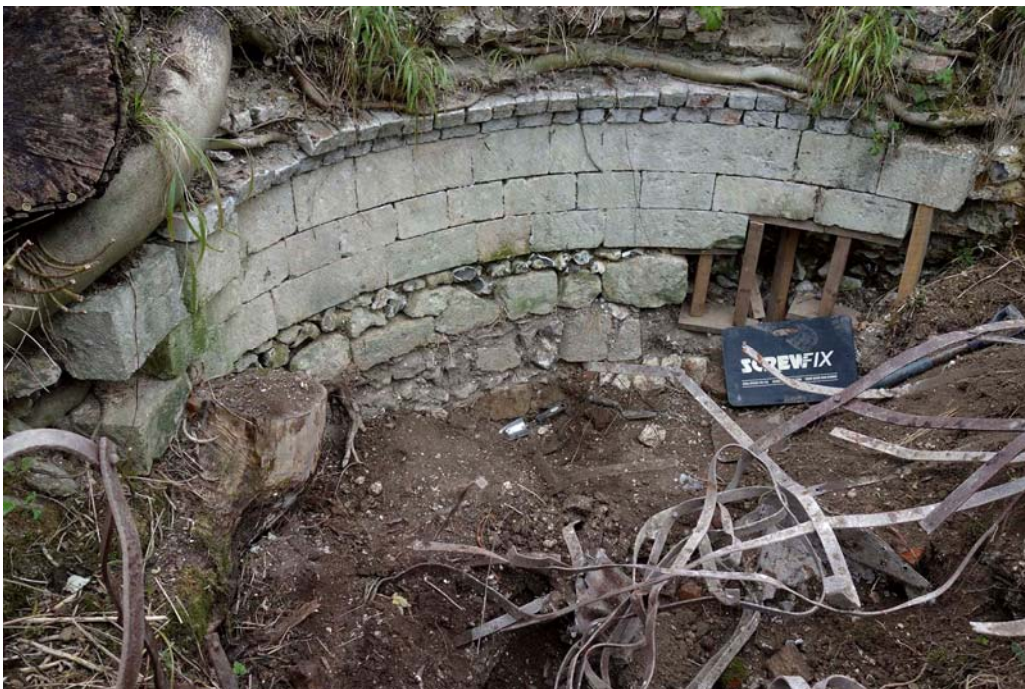
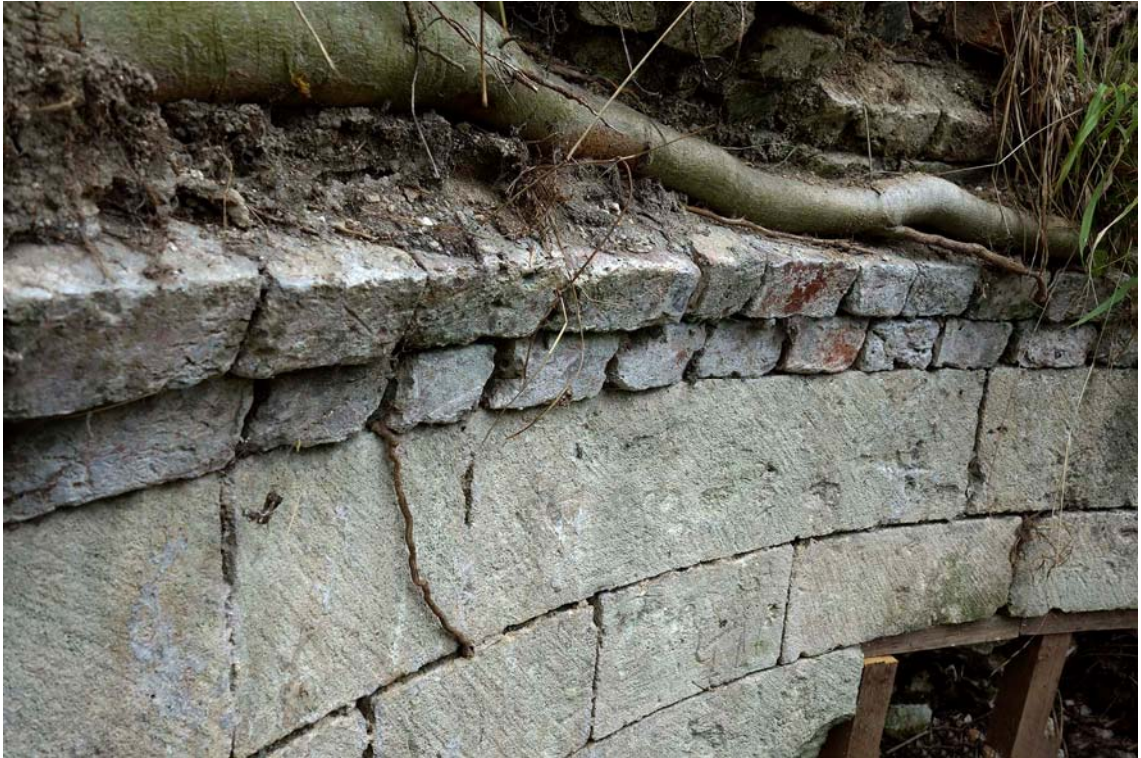
- 15.5 The masonry surviving at the top of the well in an arc on the north side is significant. It now consists of three courses of finely joined Quarr stone blocks, with diagonal tooling, though this treatment may have continued higher, the present top of the well being crudely formed of loose brickwork.

Figure 40. Remains of upper well lining, looking north.

Figure 41. Remains of upper well lining (detail).
