19 November 2022

MERDON CASTLE, NEAR HURSLEY, HANTS

Observations on the Historic Architecture

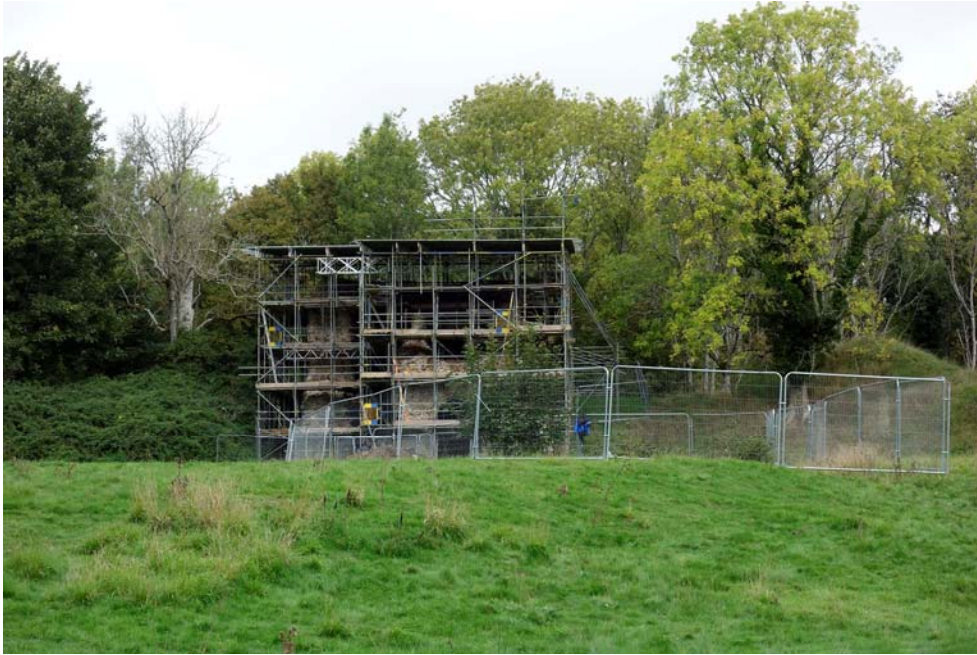
Figure 6. Gatehouse from south.

Interpretation of the building is made more challenging because of the major loss of primary surfaces, both external and internal, resulting from deliberate robbing of facing masonry, frost action, and collapse—notably the loss of the south-west corner of the structure. Apart from a few tiny fragments, almost all that survives is corework, for in some areas the upstanding elevations appear to be up to a metre back from the original wall faces. The form and position of features such as vaults, doorways, windows, stairs has to be worked out from fragmentary remains, or from the way the corework has eroded.

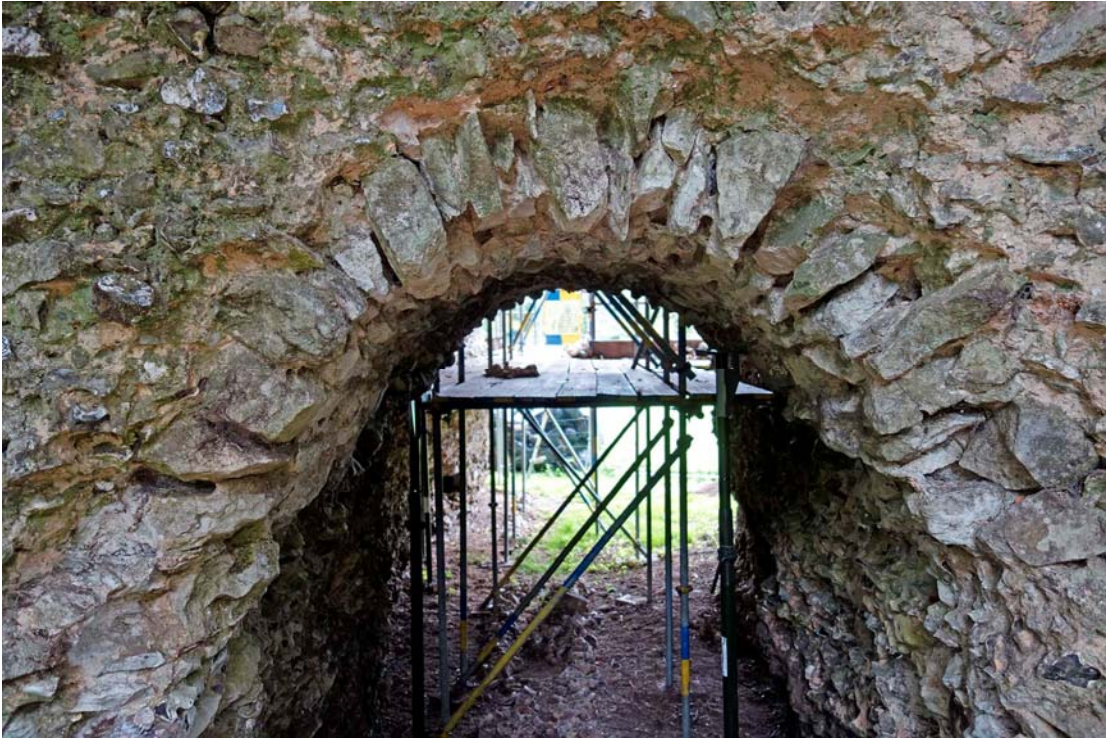
Figure 12. Entrance arch seen in section, showing voussoirs.

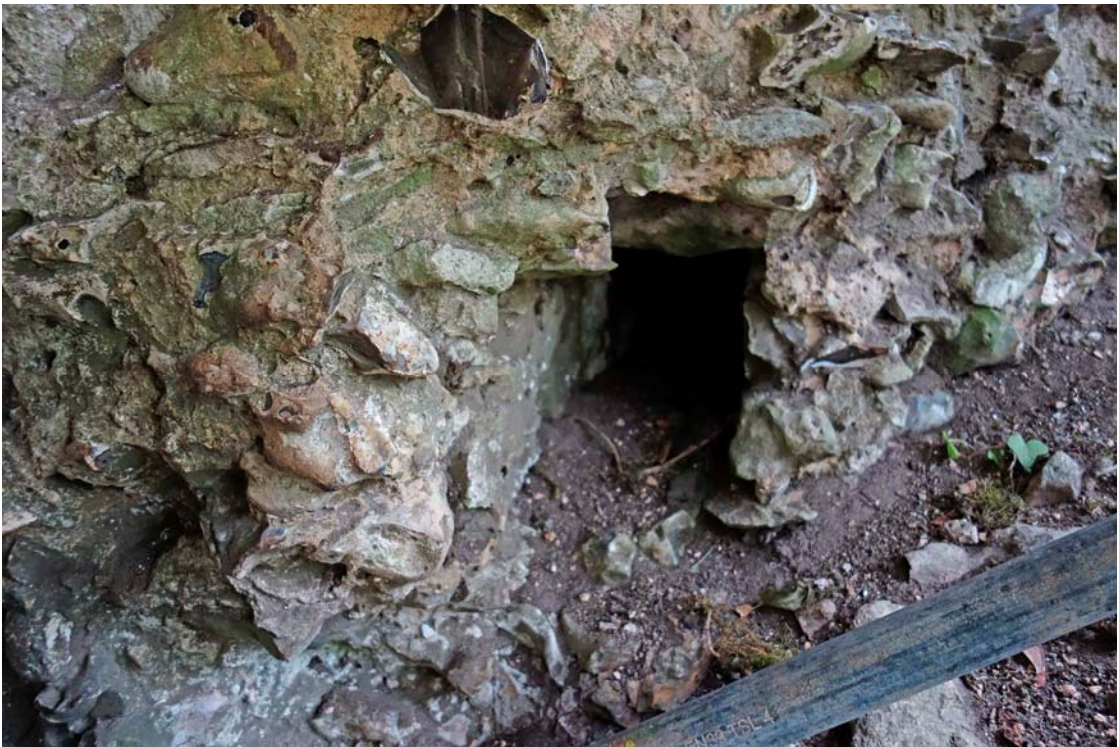
The door would have opened inwards, towards the passage, in the normal way, and when closed would have been secured by a timber draw-bar. The draw-bar socket survives on the west side, now almost at ground level owing to the considerable depth of build-up (1.0 to 1.5m) at the north end of the passage.

Figure 13. Draw-bar socket on west side of entrance.

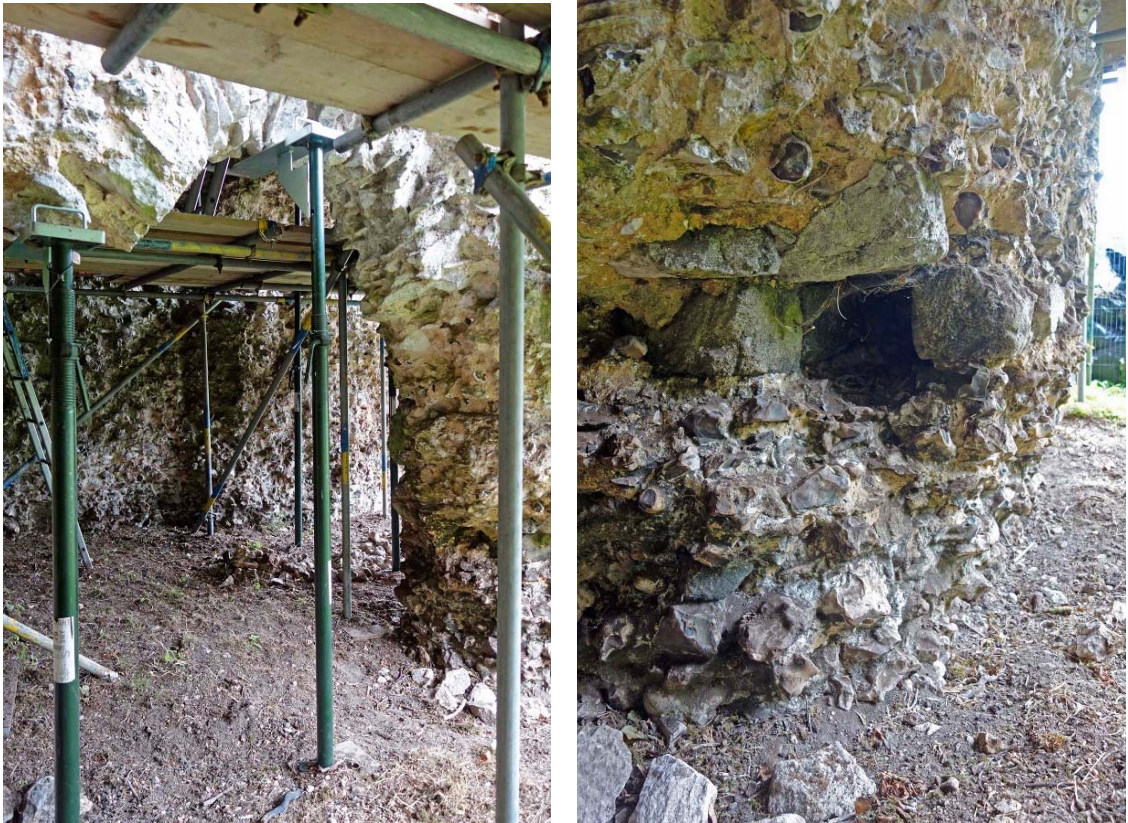
Figure 15. (left): Doorway linking entrance passage and adjacent room. (right): Possible draw-bar socket.

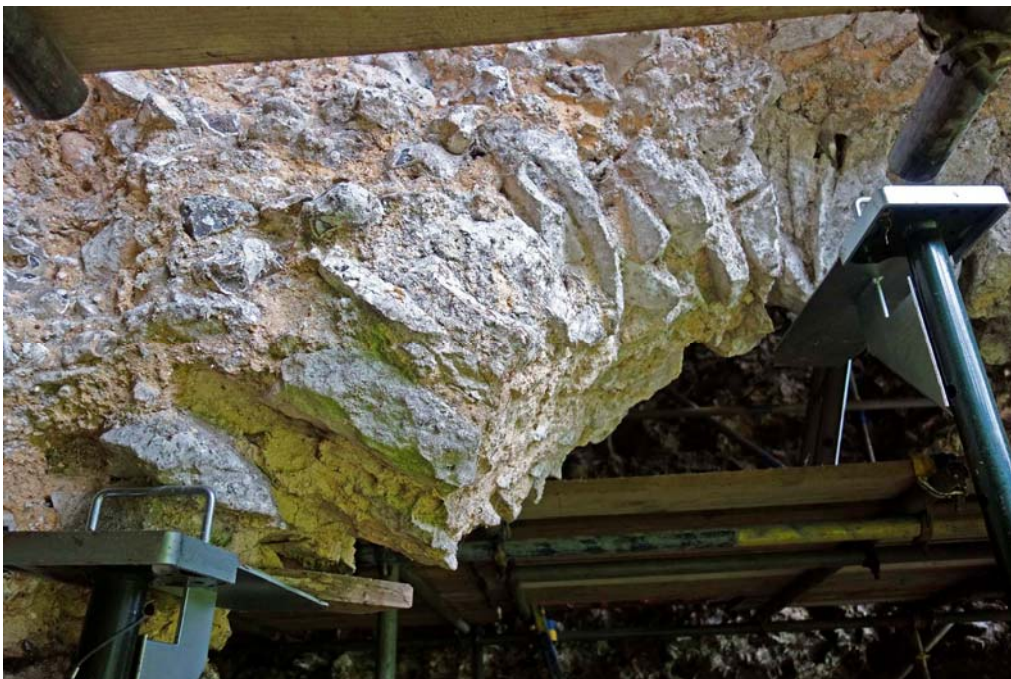
Figure 16. Head of doorway in spine wall.

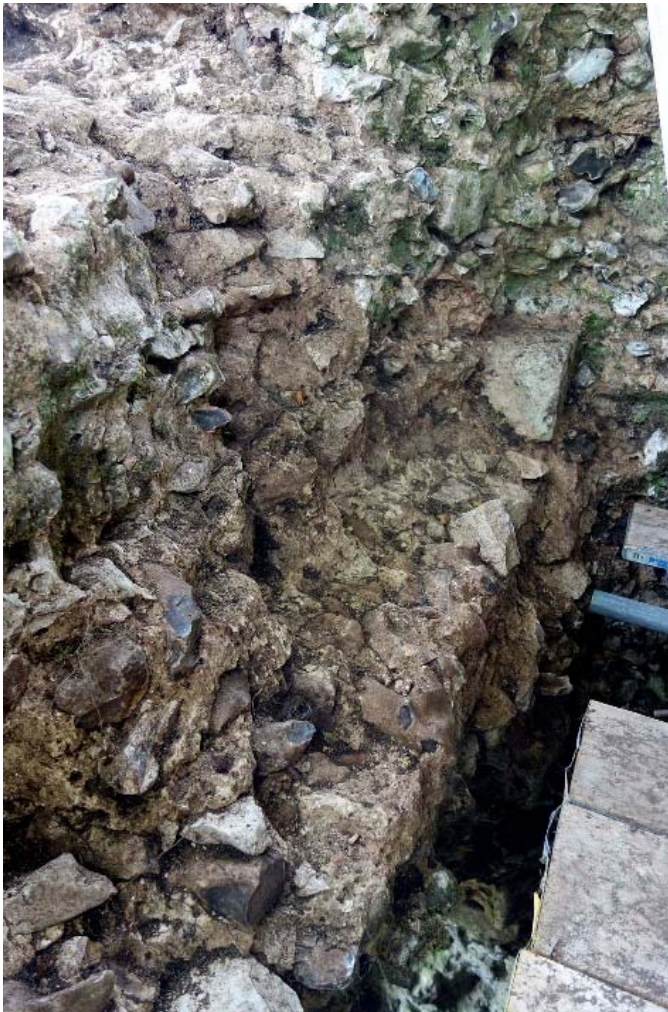
Figure 21. View SW into corner of first-floor room in E half of gatehouse showing isolated block ?from floor in the corner of the room.

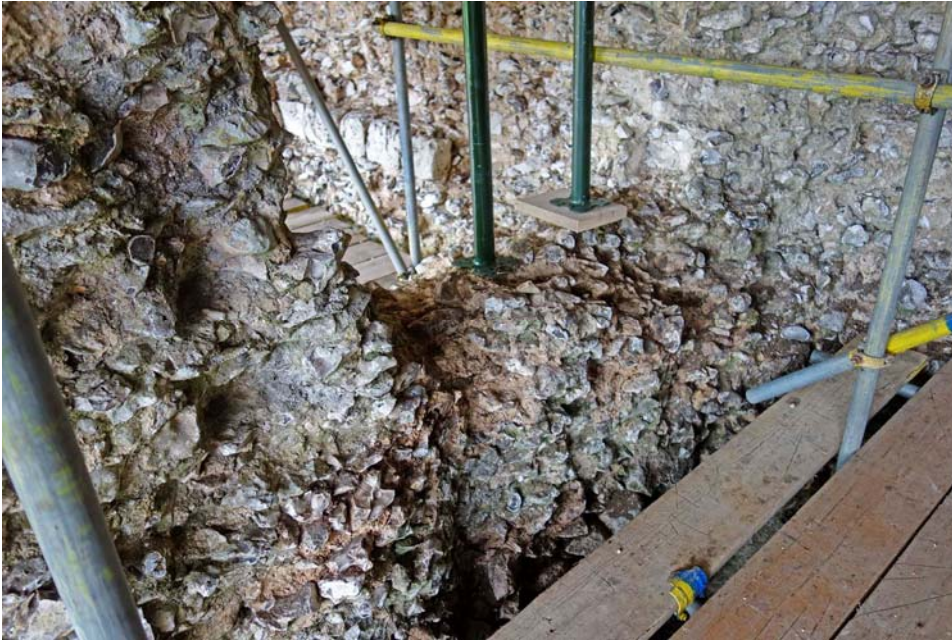
- 9.7 Comparing this evidence with the line of blocks noted on the north wall of the entrance passage, it appears that the first floor level of the room over the eastern half of the gatehouse was slightly lower than that over the passage. There was therefore a step at this level between the two halves (Figure 22).

Figure 22. View WNW at corework of step through the spine wall at first-floor level. The line of chalk blocks in the north wall, visible through the doorway, defines the higher first floor level over the gate passage.

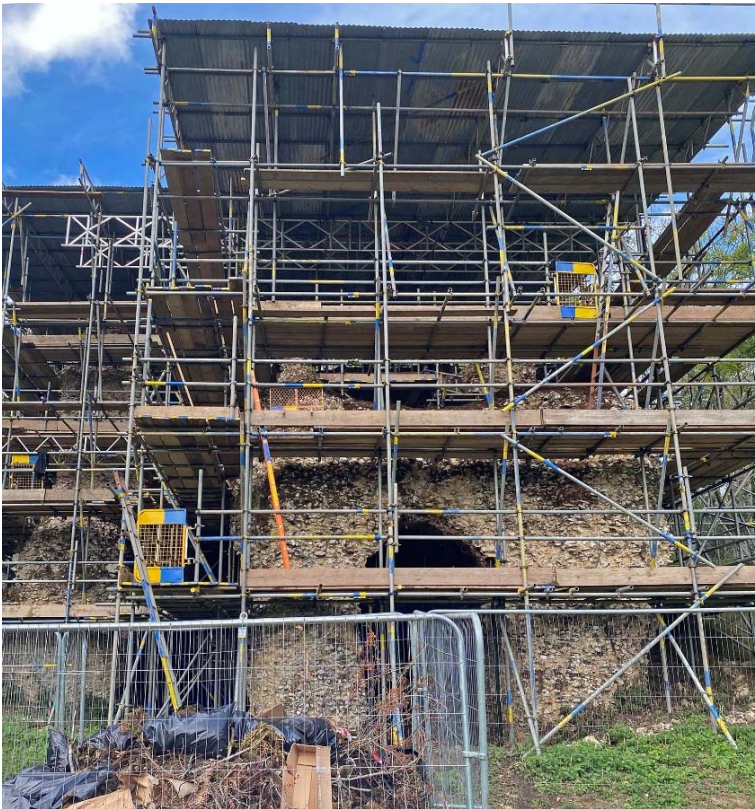
Figure 23. South elevation of gatehouse showing (right) the doorway into the eastern ground-floor room.

The south wall of the east half of the gatehouse is reasonably intact (Figure 23), but again consists only of corework, all facing masonry of the wall, and the ashlar of the central doorway having been completely lost.

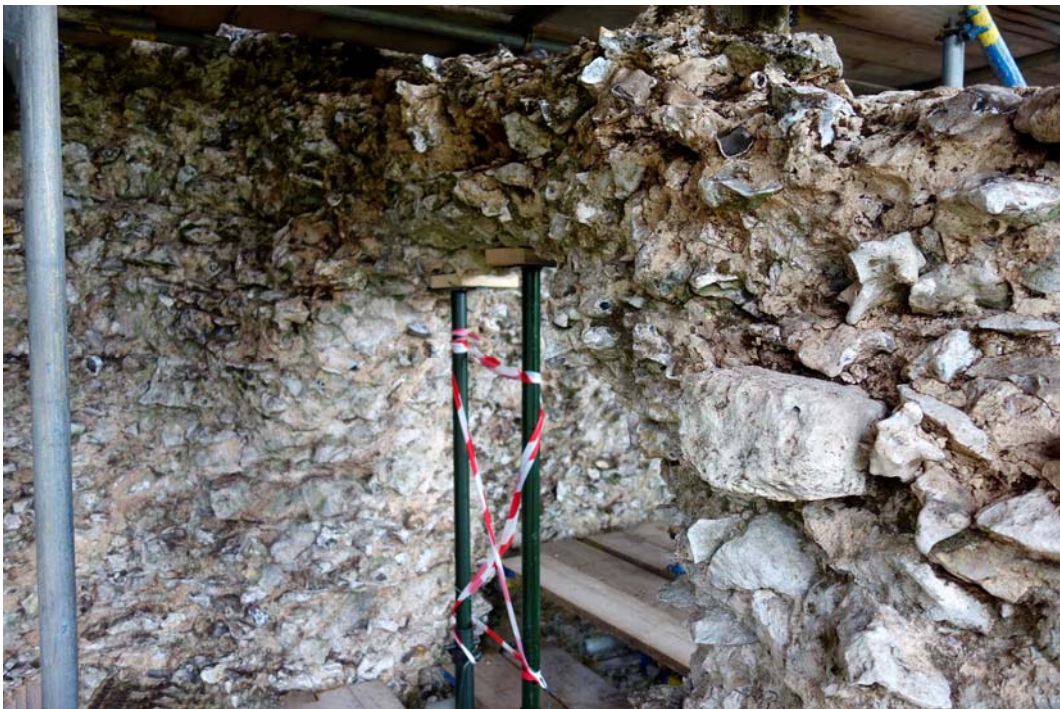
- 10.1 We have noted the evidence for stone floors over the gate passage and over the ground-floor room in the eastern half of the gatehouse. There were first-floor rooms over each half of the building, linked by a doorway through the spine wall. Astonishingly the corework of the arch of this doorway survives (Figure 25 and Figure 26).

Figure 25. Remains of doorway between first-floor rooms, looking north-east.

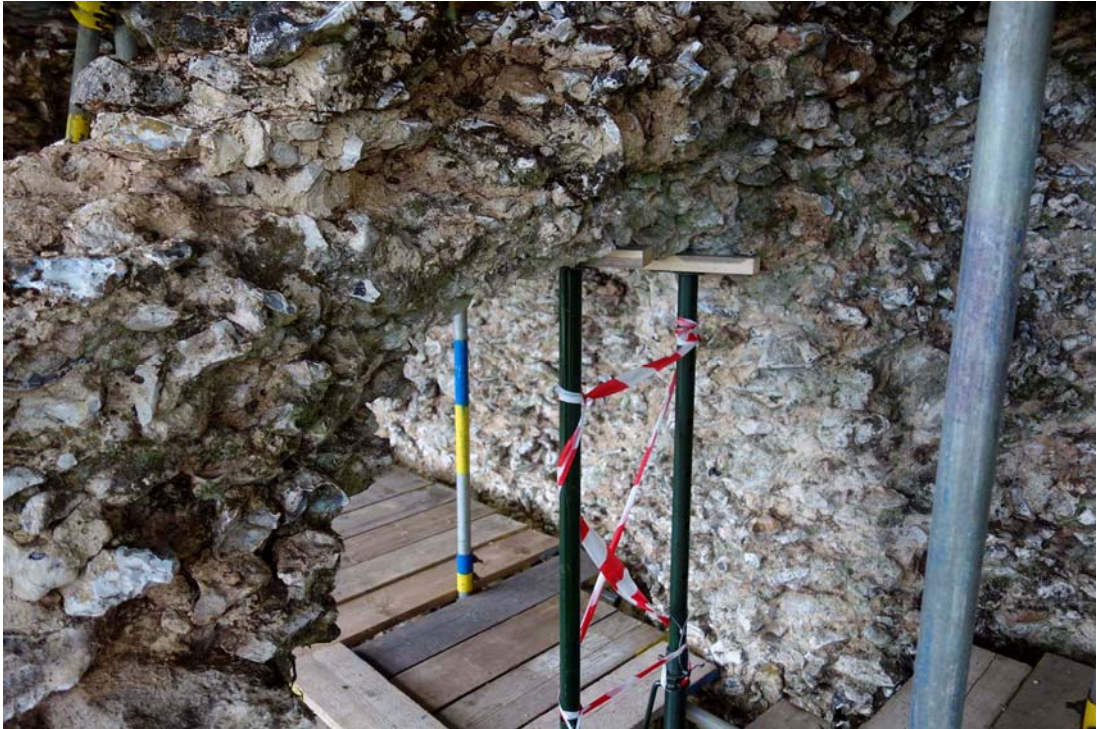
Figure 26. Remains of doorway between first-floor rooms, looking north-west.

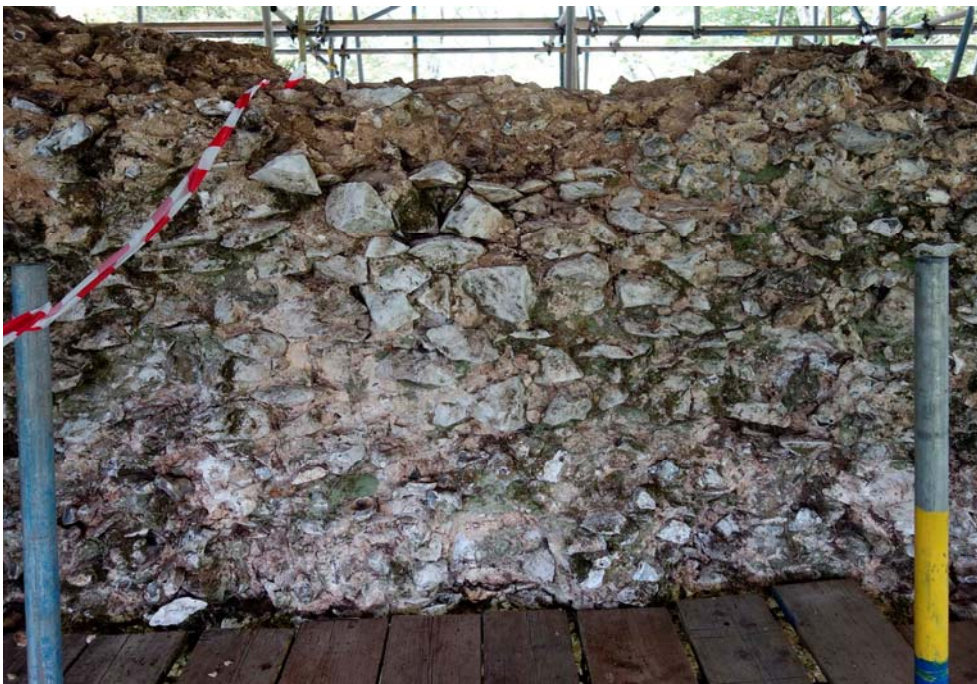
- 10.4 The core work at the top of the gatehouse comprises mainly random rubble, probably discarded from the building process (Figure 29 and Figure 30), and it seems that by the time construction reached this level supplies of flints were running short.

Figure 29. Inner face of top of north wall of gatehouse western half.

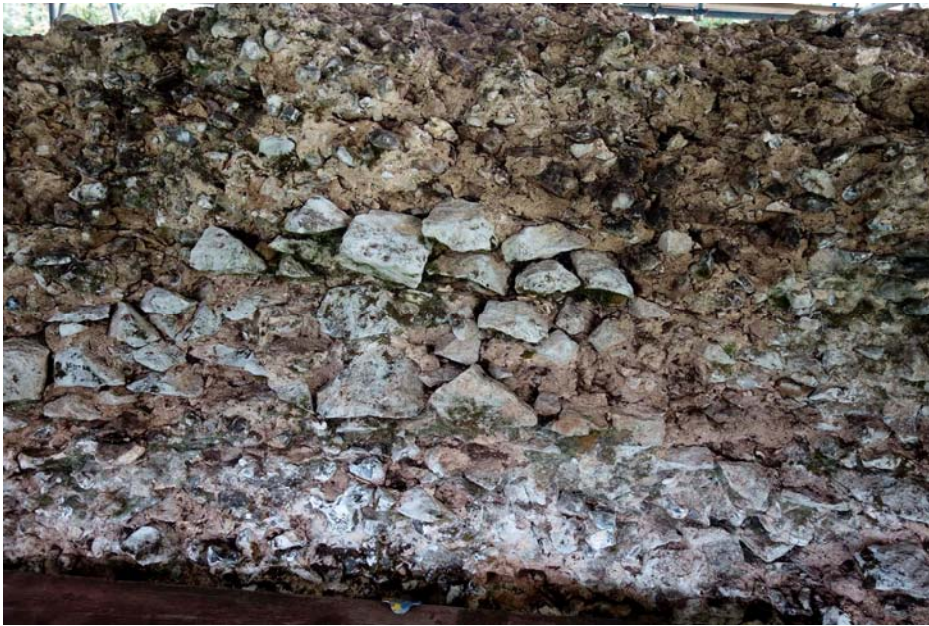
Figure 30. Inner face of top of north wall of gatehouse eastern half.

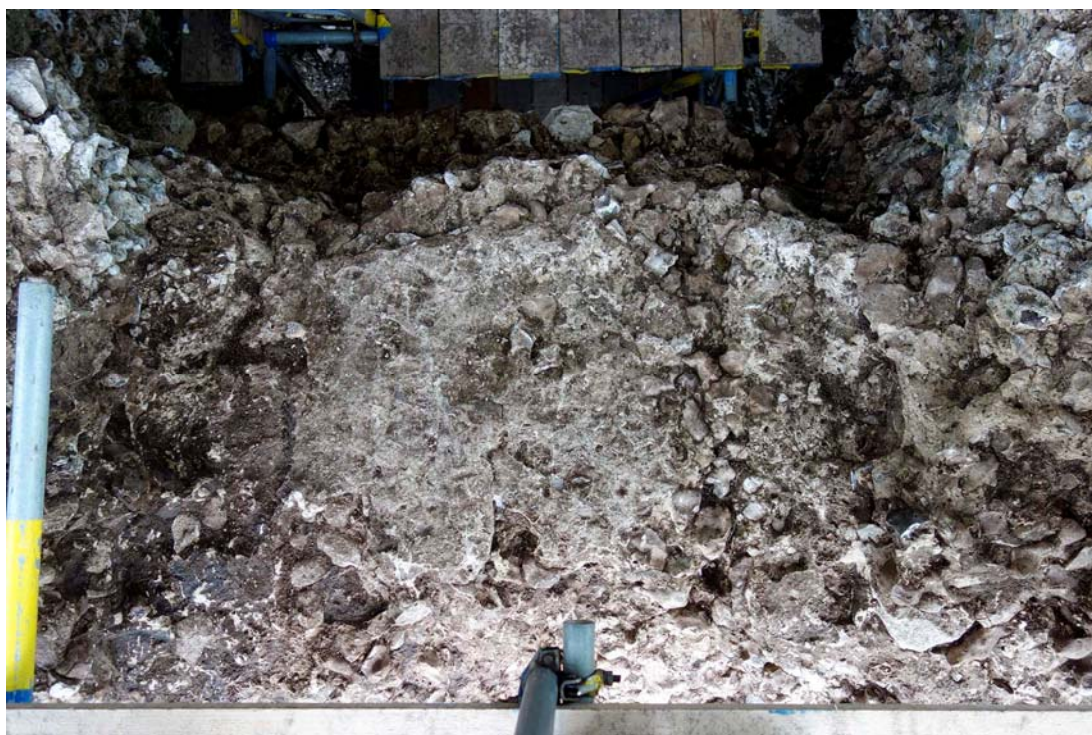
12.3 Rather more features of interest were seen within the eastern half of the building. Here the south wall had survived, and the sill of a window was observed (Figure 32), whose level was consistent with the first floor as defined by the surviving chalk blocks already discussed.

Figure 32. Plan view of sill of window of first-floor room in east half of gatehouse, north at top.

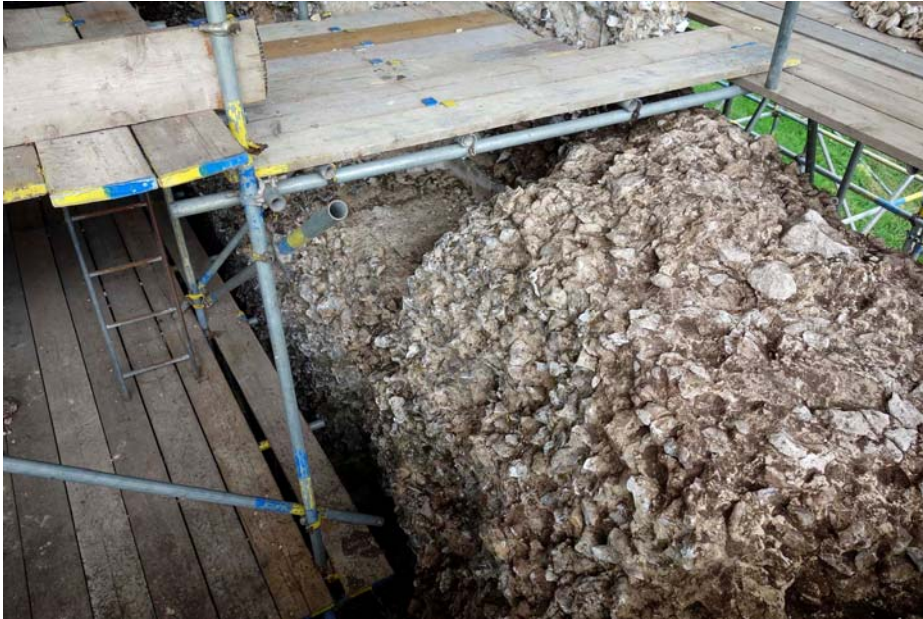
12.4 The other significant feature of this first-floor room is what looks like a niche in the east wall (Figure 33).

Figure 33. East wall, first-floor level. Niche feature (beneath scaffolding walkway).

- 12.5 This is at the wrong level for a hearth, and in any case there are no signs of a flue. It does not continue through the thickness of the wall, and the floor is solid, so it is not a garderobe.
- 12.6 At the bottom of the enclosing walls of the niche are two courses of Quarr stone ashlar blocks (Figure 34), and these are of importance as dating evidence. Quarr stone was used locally in the late eleventh/early twelfth centuries, but supplies began to run out in the first half of the twelfth century. The fine diagonal tooling, and narrow joints (Figure 35) are also typical of early twelfth-century work, notably that of Bishop Henry of Blois to whom is attributed the construction of Merdon Castle.

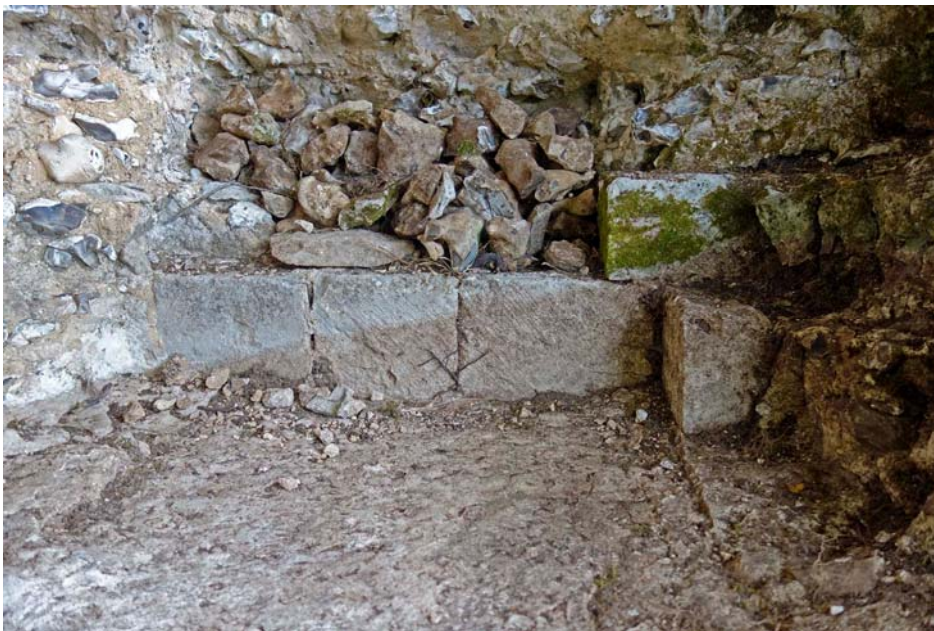
Figure 34. Rear of niche, east wall of first-floor room of eastern half of the building.

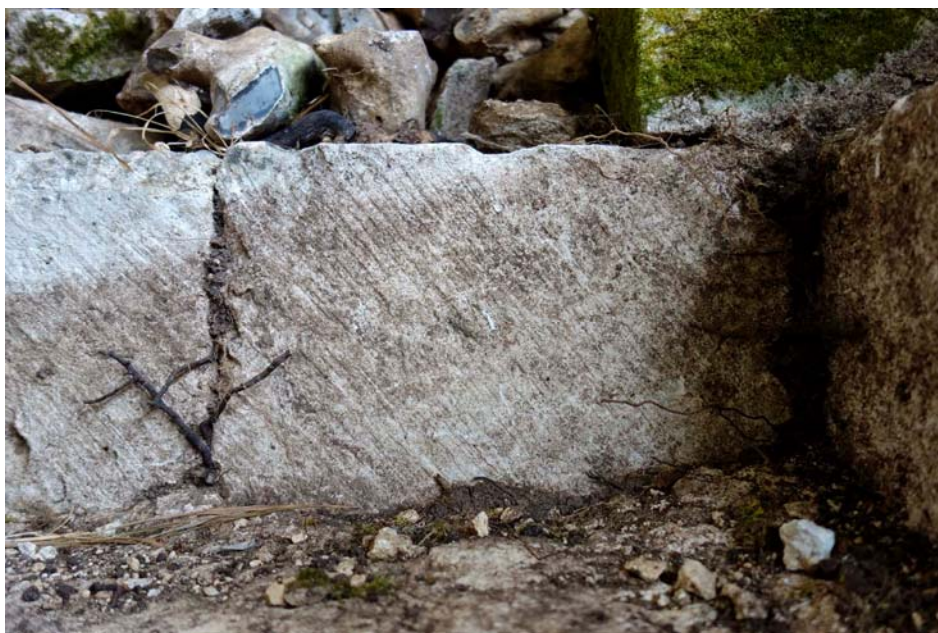
Figure 35. Tooling of masonry at rear of niche.

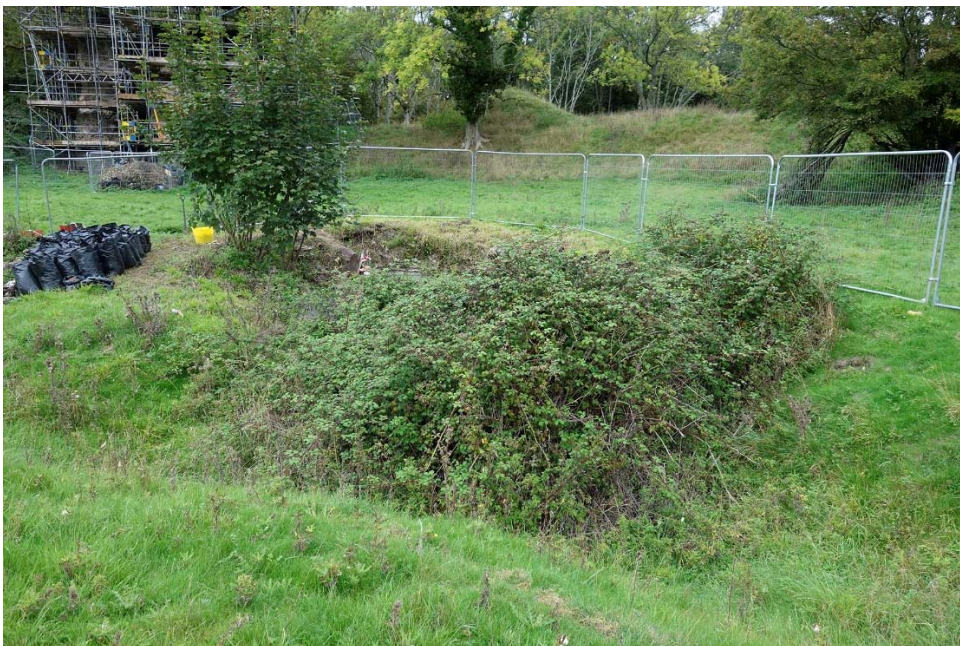
- 15.1 A supply of fresh water was essential to a medieval castle. Merdon was, as we have seen, constructed high up a hillside, so water could only be provided by means of a deep well. This was dug towards the south side of the low motte.
- 15.2 Access was provided by means of what originally was presumably a flight of steps running from the south. This area was completely obscured by brambles at the time of my visit (Figure 38).

Figure 38. Path or steps down to the well, looking north, with gatehouse in background.

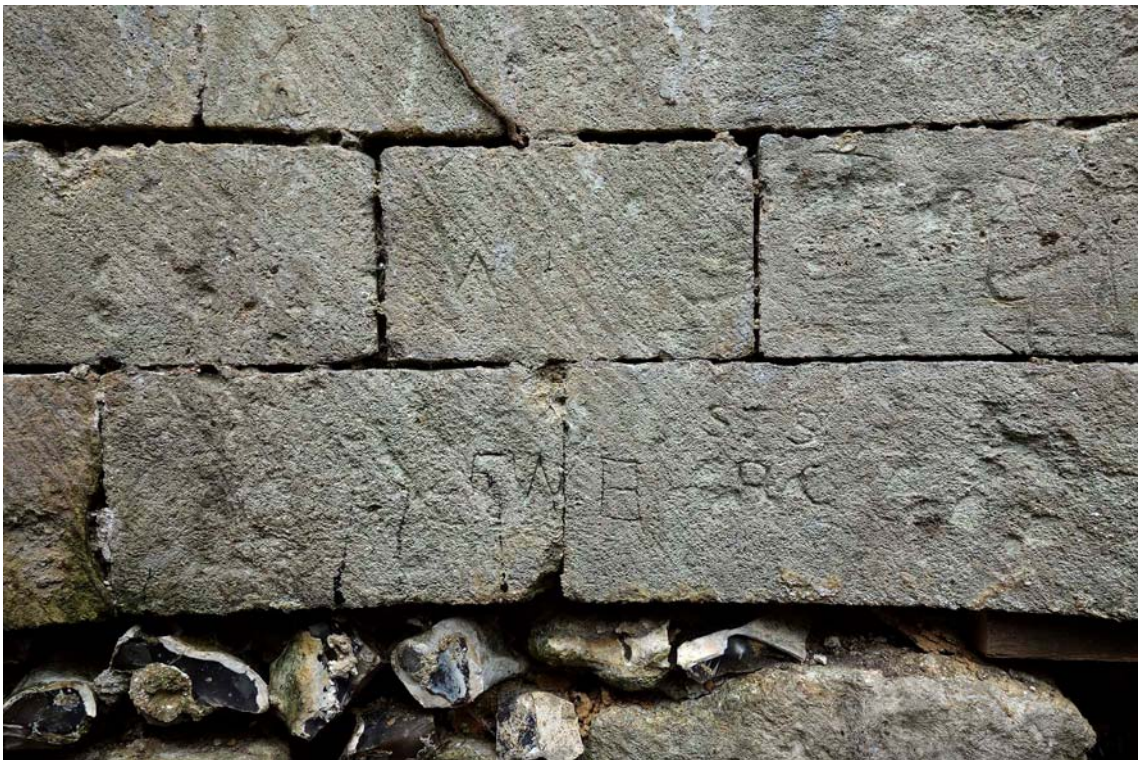
Figure 42. Quarr blocks with graffiti.

- 15.6 The ashlar masonry is typical of the early twelfth century, and there is no doubt that the well was a primary feature of the twelfth-century castle.
- 15.7 Modern features here included graffiti (Figure 42), probably not earlier than the nineteenth century on stylistic grounds. A small brass bell, possibly a sheep bell, was discovered in the upper fill of the well (Figure 43).
